Munroe Brook Watershed Northern Section - FRP BMPs Shelburne & South Burlington, VT

Project: 14-042
Prepared By: ALD
09/14/2016
1 inch = 1500 feet

Munroe Brook Watershed Southern Section - FRP BMPs Shelburne & South Burlington, VT

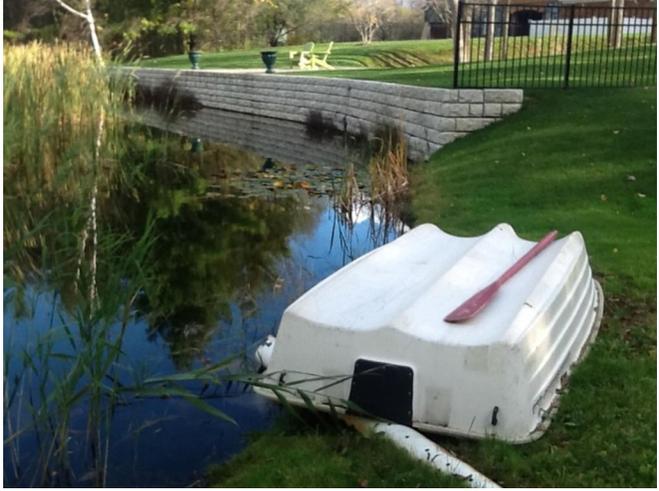
ID#: M01		
Name: Westview Estates

Permit #: 1-0607 A		
Concept Description: Conversion of existing BMP to 2002 standard		
Notes/Feasibility: 12 in horizontal stand pipe. Head available dependent on lowering water surface level, existing pond has +/-1' of freeboard.		
GENERAL SITE INFORMATION	RETROFIT DETAILS	
Site Contact Info: Shelburne	Project Candidate: Tier II	
Ownership:	New or Retrofit BMP: Retrofit	
Land Use 1: Residential	Proposed Retrofit Practice: Pond	
Land Use 2:	Non-Structural Controls: No	
Existing BMP on site? Yes	Maintenance Burden: Moderate	
Is site a hotspot? No	Benefits: Storage: Yes Water Quality: Yes Recharge: No Repair: No Other: N/A	Conflicts: Soils: No Access: No Land Use: No Utilities: No High WT: Unknown Wetlands: Yes Demo: No Other: N/A
Soils: C		
SIZING INFORMATION		
Drainage Area (ac): 29.90		
Impervious Area (ac): 4.01		
Practice Area Available(ft²): 20700		
Existing Head Available? 4-5' Est.

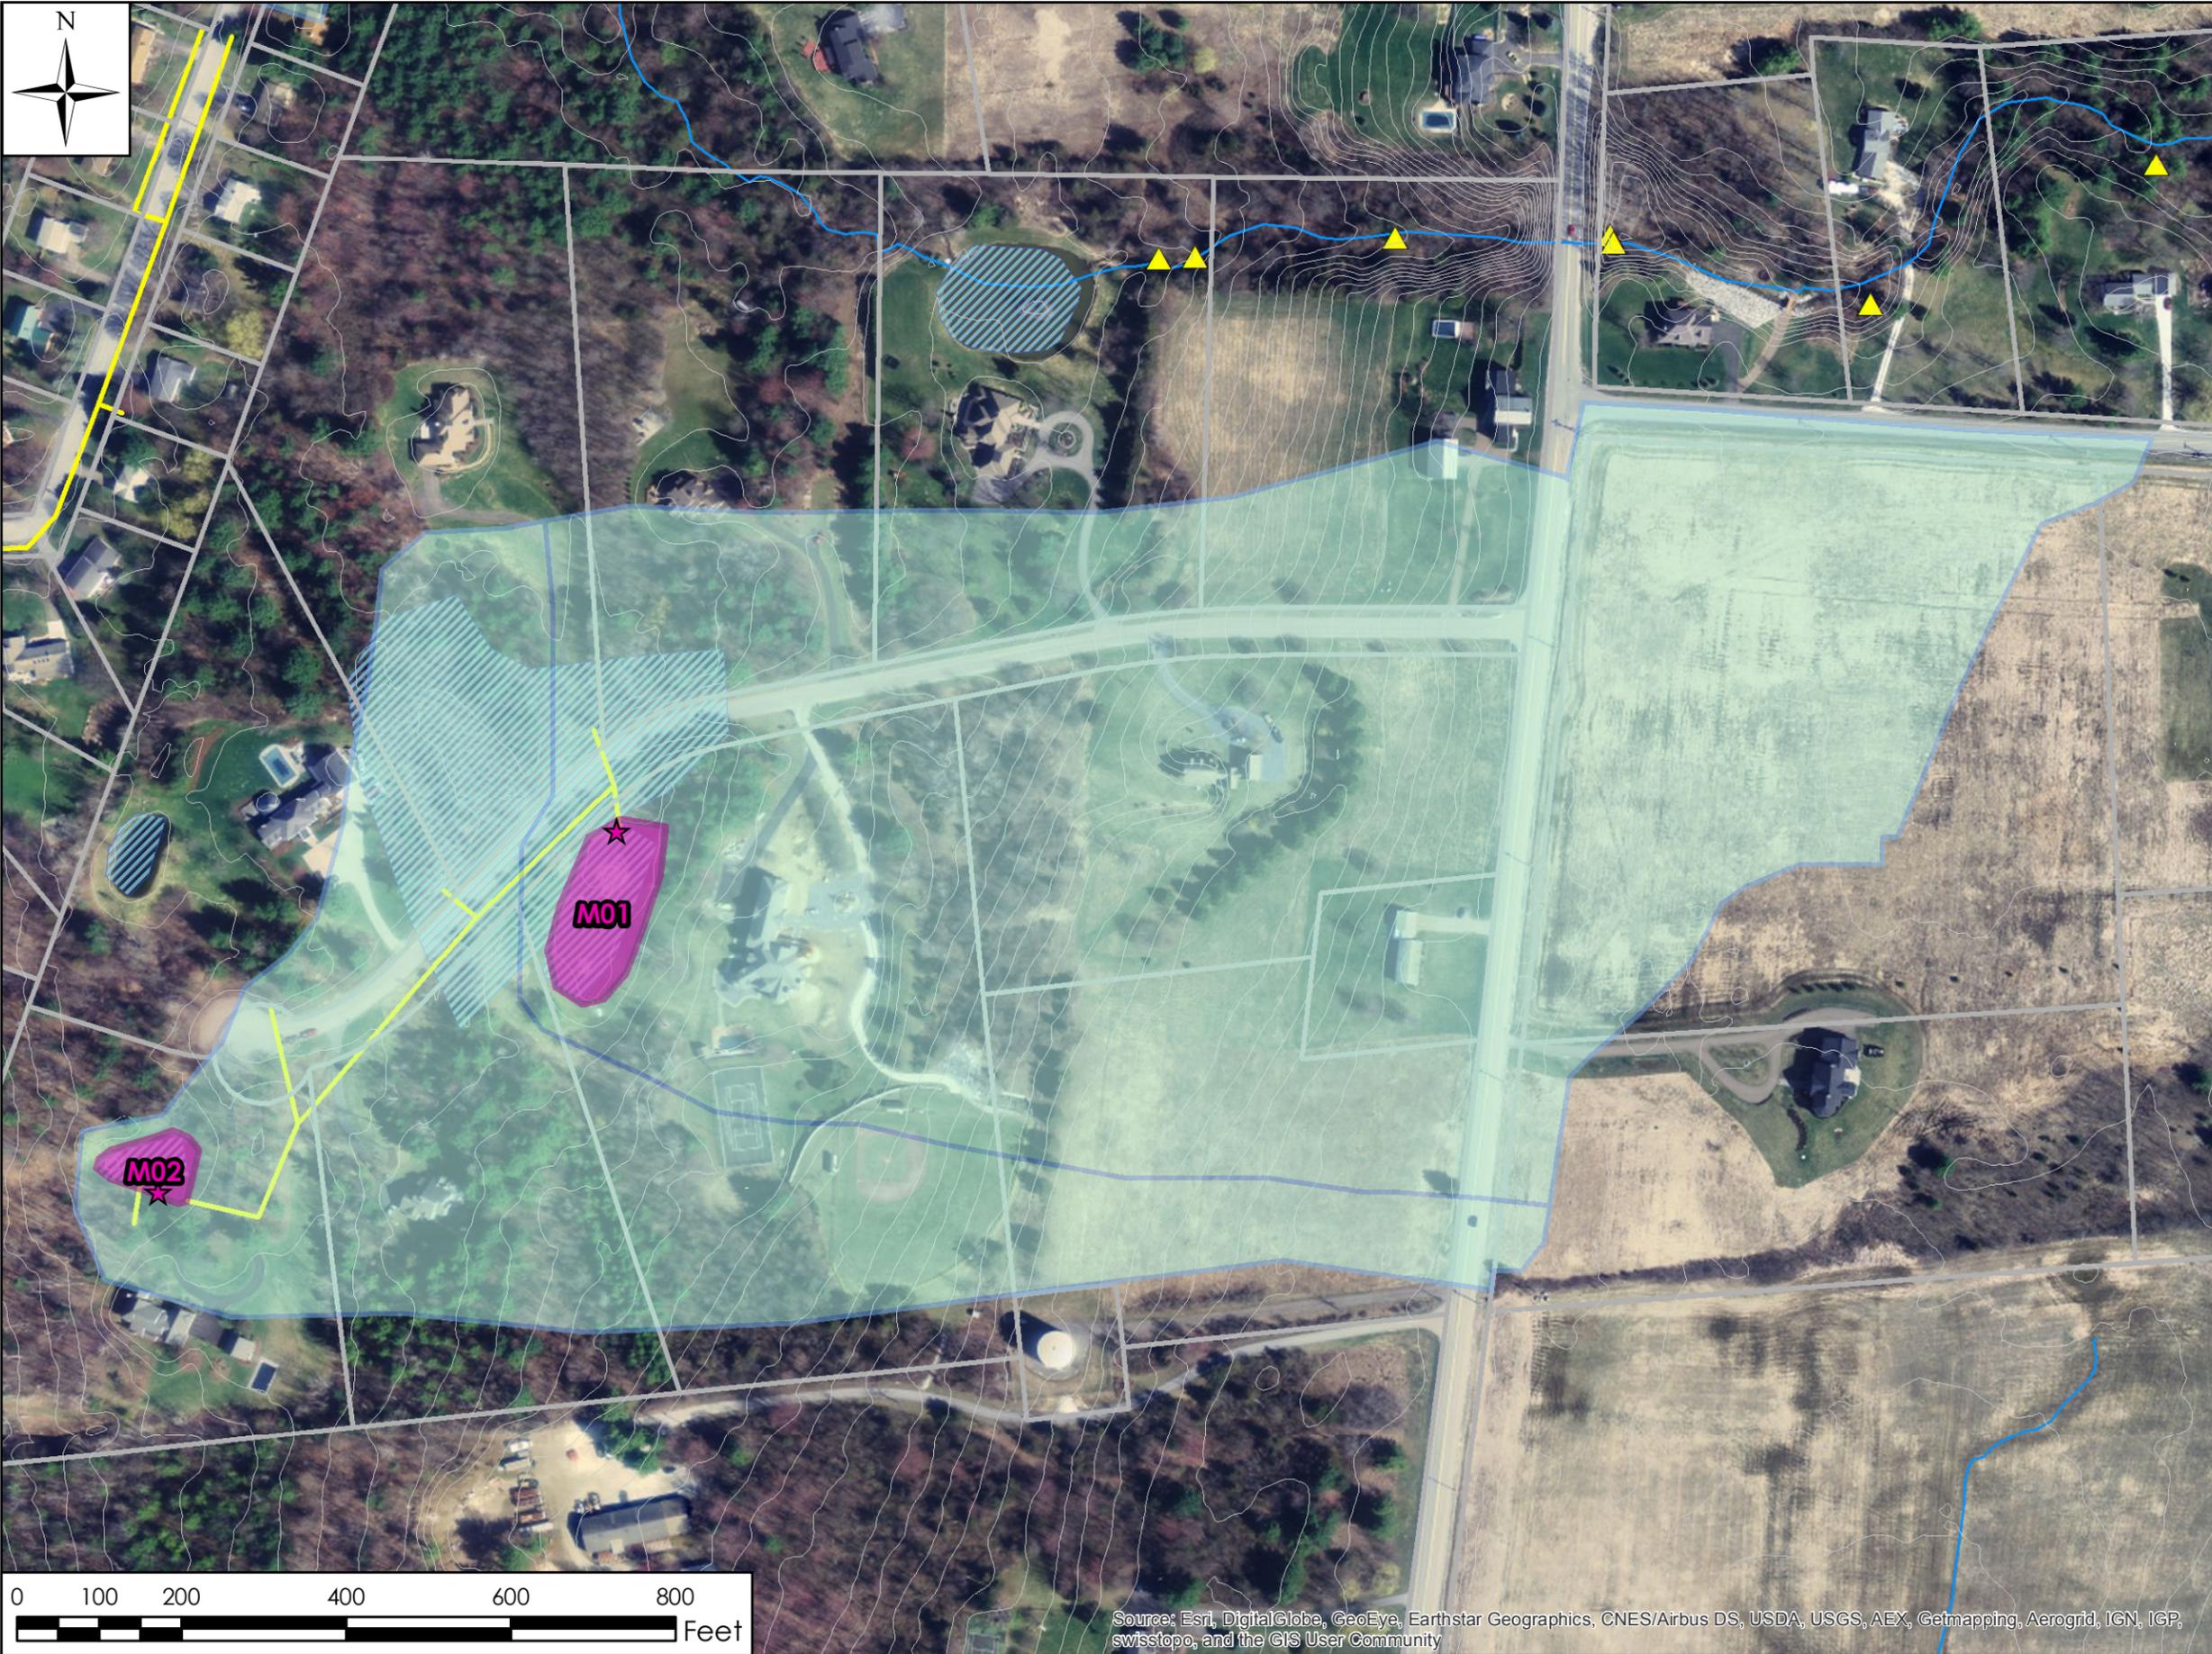
**M1 & M2 - Westview Est
Shelburne, VT**

ID#: M02		
Name: Westview Estates	No Image Available	
Permit #: 1-0607 B		
Concept Description: Retrofit of existing BMP to 2002 standards		
Notes/Feasibility:		
GENERAL SITE INFORMATION	RETROFIT DETAILS	
Site Contact Info: Shelburne	Project Candidate: Tier II	
Ownership:	New or Retrofit BMP: Retrofit	
Land Use 1: Residential	Proposed Retrofit Practice: Pond	
Land Use 2:	Non-Structural Controls: no	
Existing BMP on site? Yes	Maintenance Burden: Moderate	
Is site a hotspot? No	Benefits: Storage: yes Water Quality: yes Recharge: No Repair: no Other: N/A	Conflicts: Soils: No Access: no Land Use: no Utilities: no High WT: unknown Wetlands: No Demo: no Other: N/A
Soils: C		
SIZING INFORMATION		
Drainage Area (ac): 12.43		
Impervious Area (ac): 0.92		
Practice Area Available(ft ²): 6900		
Existing Head Available? N/A

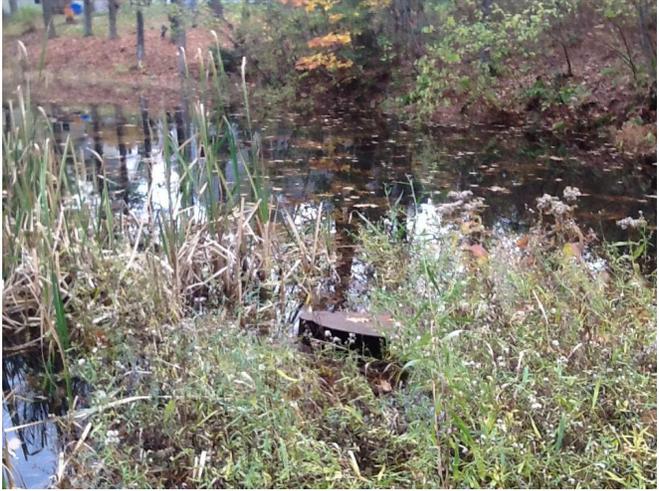
ID#: M03		
Name: Deer Run

Permit #: 1-0732 B		
Concept Description: Expand existing BMP		
Notes/Feasibility: Outlet clogged - unable to verify low flow orifices.		
GENERAL SITE INFORMATION	RETROFIT DETAILS	
Site Contact Info: Shelburne	Project Candidate: Tier I	
Ownership:	New or Retrofit BMP: Retrofit	
Land Use 1: Residential	Proposed Retrofit Practice: Pond	
Land Use 2:	Non-Structural Controls: No	
Existing BMP on site? Yes	Maintenance Burden: Moderate	
Is site a hotspot? No	Benefits: Storage: Yes Water Quality: Yes Recharge: No Repair: Yes Other: N/A	Conflicts: Soils: No Access: Yes Land Use: No Utilities: No High WT: Unknown Wetlands: No Demo: No Other: N/A
Soils: C		
SIZING INFORMATION		
Drainage Area (ac): 15.40		
Impervious Area (ac): 3.23		
Practice Area Available(ft ²): 4600		
Existing Head Available? 2-3' Est.

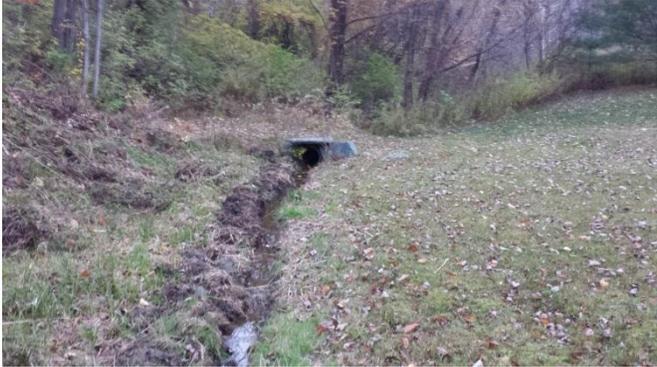
ID#: M04		
Name: Farmstead Drive

Permit #: 1-0732 C		
Concept Description: Verify installed as designed		
Notes/Feasibility: No retrofit required provided that system is installed per assumed design. To be verified.		
GENERAL SITE INFORMATION	RETROFIT DETAILS	
Site Contact Info: Shelburne	Project Candidate: Tier II	
Ownership:	New or Retrofit BMP: Retrofit	
Land Use 1: Residential	Proposed Retrofit Practice: Pond	
Land Use 2:	Non-Structural Controls: no	
Existing BMP on site? Yes	Maintenance Burden: Moderate	
Is site a hotspot? No	Benefits: Storage: yes Water Quality: yes Recharge: No Repair: no Other: N/A	Conflicts: Soils: No Access: no Land Use: no Utilities: no High WT: unknown Wetlands: No Demo: no Other: N/A
Soils: C		
SIZING INFORMATION		
Drainage Area (ac): 5.60		
Impervious Area (ac): 1.83		
Practice Area Available(ft ²): 2200		
Existing Head Available? 3' Est.

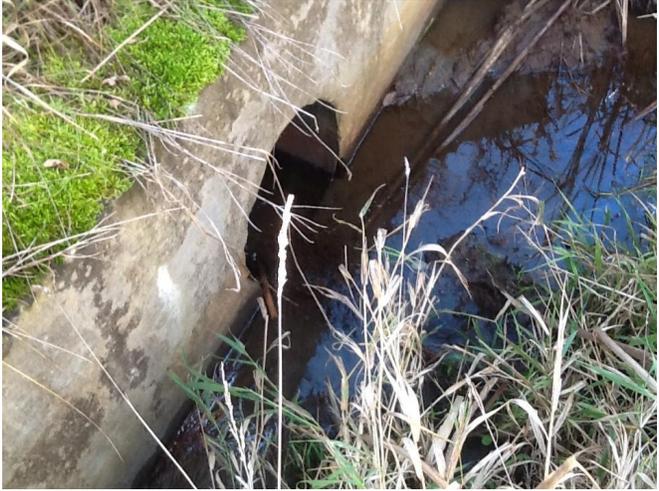
ID#: M05		
Name: Pinnacle at Spear

Permit #: 1-1155 P2		
Concept Description: Retrofit of existing BMP to 2002 standards		
Notes/Feasibility:		
GENERAL SITE INFORMATION	RETROFIT DETAILS	
Site Contact Info: South Burlington	Project Candidate: Tier I	
Ownership:	New or Retrofit BMP: Retrofit	
Land Use 1: Residential	Proposed Retrofit Practice: Pond	
Land Use 2:	Non-Structural Controls: No	
Existing BMP on site? Yes	Maintenance Burden: Minimal change	
Is site a hotspot? No	Benefits: Storage: Yes Water Quality: Yes Recharge: No Repair: No Other: N/A	Conflicts: Soils: No Access: Yes Land Use: No Utilities: No High WT: Yes Wetlands: No Demo: No Other: N/A
Soils: D		
SIZING INFORMATION		
Drainage Area (ac): 10.20		
Impervious Area (ac): 3.86		
Practice Area Available(ft ²): 17400		
Existing Head Available? N/A

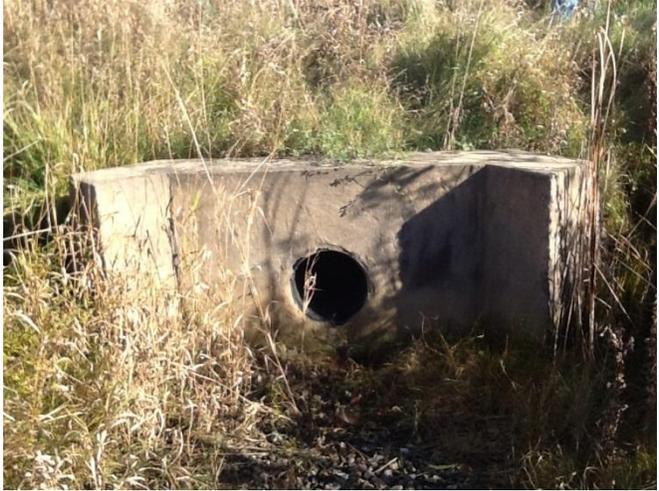
ID#: M06		
Name: Pinnacle at Spear

Permit #: 1-1155 P5		
Concept Description: Retrofit of existing BMP to 2002 standards		
Notes/Feasibility:		
GENERAL SITE INFORMATION	RETROFIT DETAILS	
Site Contact Info: South Burlington	Project Candidate: Tier I	
Ownership:	New or Retrofit BMP: Retrofit	
Land Use 1: Residential	Proposed Retrofit Practice: Pond	
Land Use 2:	Non-Structural Controls: No	
Existing BMP on site? Yes	Maintenance Burden: Minimal change	
Is site a hotspot? No	Benefits: Storage: Yes Water Quality: Yes Recharge: No Repair: No Other: N/A	Conflicts: Soils: No Access: Yes Land Use: No Utilities: No High WT: Yes Wetlands: No Demo: No Other: N/A
Soils: D		
SIZING INFORMATION		
Drainage Area (ac): 1.76		
Impervious Area (ac): 0.06		
Practice Area Available(ft ²): 11700		
Existing Head Available? N/A

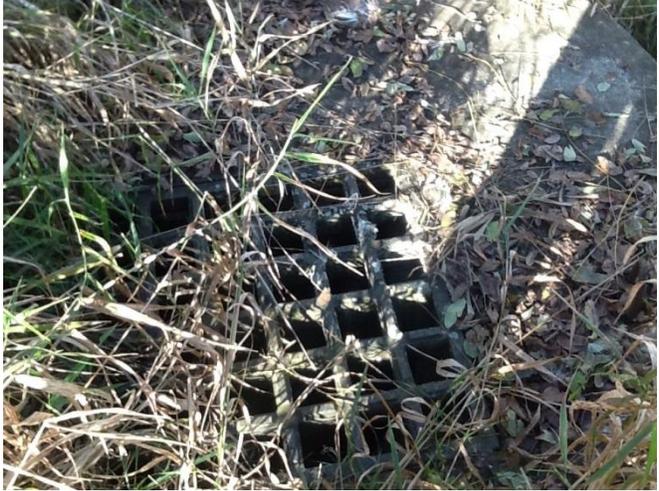
ID#: M07		
Name: Pinnacle at Spear

Permit #: 1-1155 P3		
Concept Description: Retrofit of existing BMP to 2002 standards		
Notes/Feasibility:		
GENERAL SITE INFORMATION	RETROFIT DETAILS	
Site Contact Info: South Burlington	Project Candidate: Tier I	
Ownership:	New or Retrofit BMP: Retrofit	
Land Use 1: Residential	Proposed Retrofit Practice: Pond	
Land Use 2:	Non-Structural Controls: No	
Existing BMP on site? Yes	Maintenance Burden: Minimal change	
Is site a hotspot? No	Benefits: Storage: Yes Water Quality: Yes Recharge: No Repair: No Other: N/A	Conflicts: Soils: No Access: Yes Land Use: No Utilities: No High WT: Yes Wetlands: No Demo: No Other: N/A
Soils: D		
SIZING INFORMATION		
Drainage Area (ac): 7.60		
Impervious Area (ac): 3.84		
Practice Area Available(ft ²): 16200		
Existing Head Available? N/A

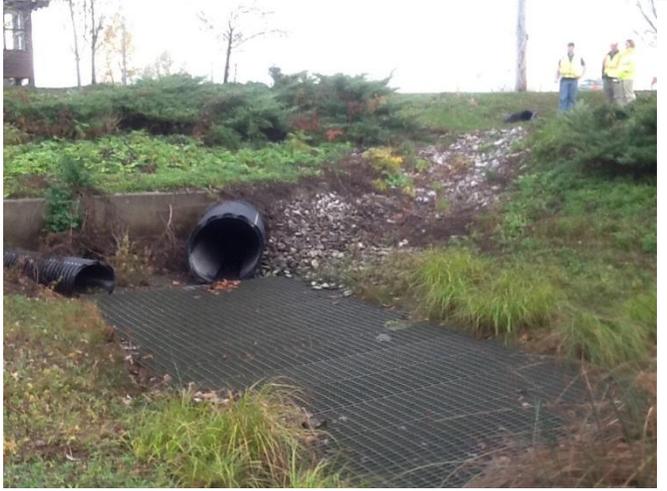
ID#: M08		
Name: Route 7

Permit #: 1-1291		
Concept Description: Retrofit of existing BMP to provide additional control as feasible.		
Notes/Feasibility: The drainage area for this practice is significantly larger than original models indicated, may limit feasibility for retrofit.		
GENERAL SITE INFORMATION	RETROFIT DETAILS	
Site Contact Info: Shelburne/VTrans	Project Candidate: Tier I	
Ownership:	New or Retrofit BMP: Retrofit	
Land Use 1: Transportation	Proposed Retrofit Practice: Pond	
Land Use 2:	Non-Structural Controls: no	
Existing BMP on site? Yes	Maintenance Burden: Moderate	
Is site a hotspot? No	Benefits: Storage: Yes Water Quality: Yes Recharge: No Repair: No Other: N/A	Conflicts: Soils: No Access: No Land Use: No Utilities: No High WT: Unknown Wetlands: No Demo: No Other: N/A
Soils: D		
SIZING INFORMATION		
Drainage Area (ac): 115.20		
Impervious Area (ac): 33.00		
Practice Area Available(ft ²): 7900

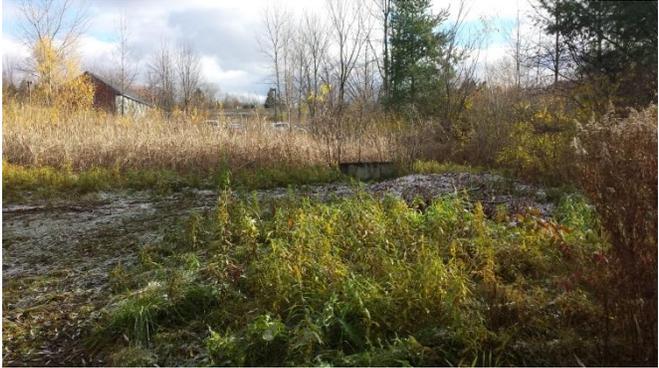
ID#: M09		
Name: Automaster - MINI Dealership

Permit #: 1-1390		
Concept Description: Expansion of existing BMP		
Notes/Feasibility: There is potential to redirect significant portions of Rt. 7 runoff to this practice if space allows.		
GENERAL SITE INFORMATION	RETROFIT DETAILS	
Site Contact Info: Shelburne/VTrans	Project Candidate: Tier I	
Ownership:	New or Retrofit BMP: Retrofit	
Land Use 1: Commercial	Proposed Retrofit Practice: Pond	
Land Use 2: Transportation	Non-Structural Controls: No	
Existing BMP on site? Yes	Maintenance Burden: Moderate	
Is site a hotspot? No	Benefits: Storage: Yes Water Quality: Yes Recharge: No Repair: Yes Other: N/A	Conflicts: Soils: No Access: Yes Land Use: No Utilities: No High WT: No Wetlands: No Demo: No Other: N/A
Soils: D		
SIZING INFORMATION		
Drainage Area (ac): 7.44		
Impervious Area (ac): 4.04		
Practice Area Available(ft²): 4000		
Existing Head Available? >10'

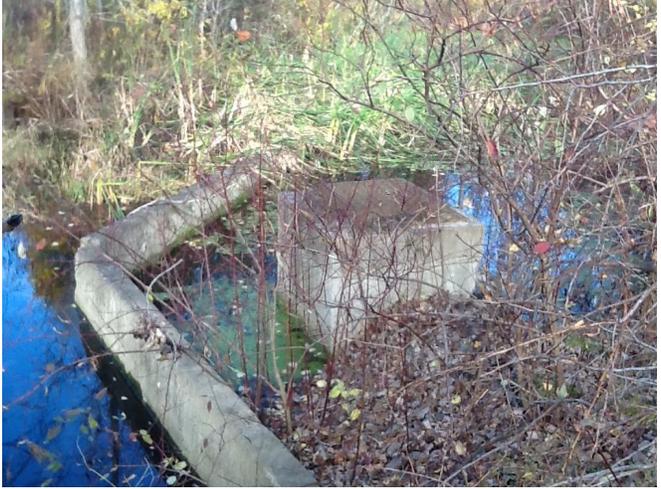
ID#: M10		
Name: Shelburne Meadows Business Park

Permit #: 1-1400 A		
Concept Description: Retrofit of existing BMP to 2002 standards		
Notes/Feasibility: 2 3" orifices at 2 ft 24 by 24 in horizontal grate at 4 ft		
GENERAL SITE INFORMATION	RETROFIT DETAILS	
Site Contact Info: Shelburne	Project Candidate: Tier II	
Ownership:	New or Retrofit BMP: Retrofit	
Land Use 1: Commercial	Proposed Retrofit Practice: Pond	
Land Use 2:	Non-Structural Controls: No	
Existing BMP on site? Yes	Maintenance Burden: Minimal change	
Is site a hotspot? No	Benefits: Storage: Yes Water Quality: Yes Recharge: No Repair: No Other: N/A	Conflicts: Soils: No Access: No Land Use: No Utilities: no High WT: Yes Wetlands: Yes Demo: Other: N/A
Soils: C		
SIZING INFORMATION		
Drainage Area (ac): 1.80		
Impervious Area (ac): 0.74		
Practice Area Available(ft ²): 2100		
Existing Head Available? 2' Est.

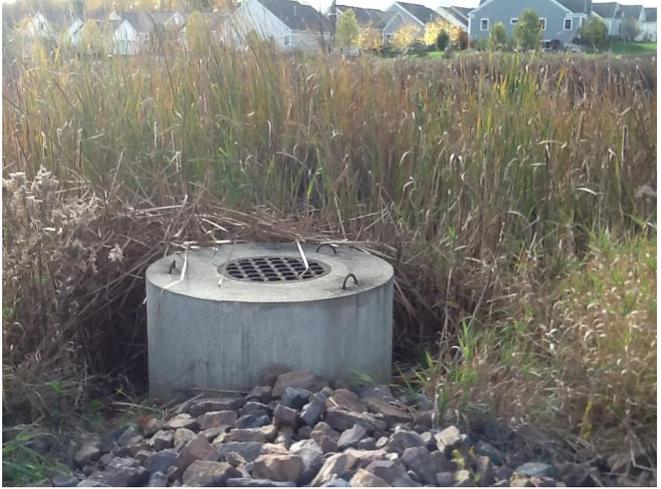
ID#: M16		
Name: South Pointe

Permit #: 3443-INDS M1		
Concept Description: Retrofit Outlet Structure		
Notes/Feasibility: While designed to 2002 standards, there was benefit to retrofitting the outlet structure		
GENERAL SITE INFORMATION	RETROFIT DETAILS	
Site Contact Info: South Burlington	Project Candidate: Tier III	
Ownership:	New or Retrofit BMP: Retrofit	
Land Use 1: Residential	Proposed Retrofit Practice:	
Land Use 2:	Non-Structural Controls: No	
Existing BMP on site? Yes	Maintenance Burden:	
Is site a hotspot? No	Benefits: Storage: Yes Water Quality: Yes Recharge: No Repair: No Other: N/A	Conflicts: Soils: No Access: No Land Use: No Utilities: No High WT: Yes Wetlands: Yes Demo: No Other: N/A
Soils: D		
SIZING INFORMATION		
Drainage Area (ac): 4.98		
Impervious Area (ac): 2.10		
Practice Area Available(ft ²): 3900		
Existing Head Available? N/A

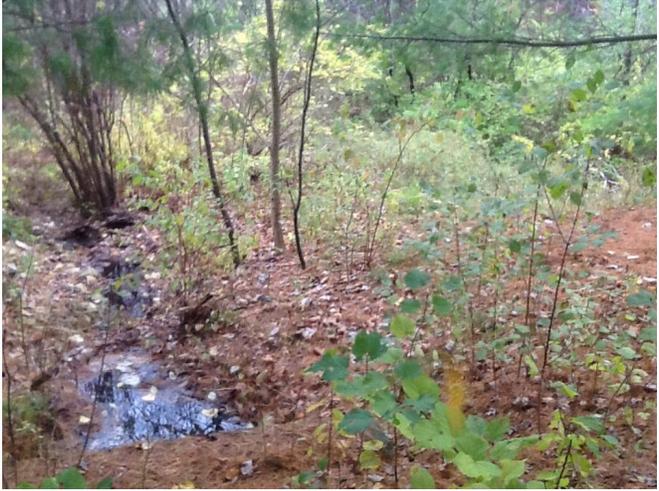
ID#: M27		
Name: Deer Run

Permit #: 1-0732		
Concept Description: Build pond in location where originally specified		
Notes/Feasibility: Proposed BMP at location indicated in permit. Existing recreation area must be demolished.		
GENERAL SITE INFORMATION	RETROFIT DETAILS	
Site Contact Info: Shelburne	Project Candidate: Tier I	
Ownership:	New or Retrofit BMP: New	
Land Use 1: Residential	Proposed Retrofit Practice: Pond	
Land Use 2:	Non-Structural Controls: N/A	
Existing BMP on site? No	Maintenance Burden: Moderate	
Is site a hotspot? No	Benefits: Storage: Yes Water Quality: Yes Recharge: No Repair: No Other: N/A	Conflicts: Soils: No Access: Yes Land Use: No Utilities: No High WT: Yes Wetlands: Yes Demo: No Other: N/A
Soils: C		
SIZING INFORMATION		
Drainage Area (ac): 8.70		
Impervious Area (ac): 1.65		
Practice Area Available(ft ²): 1500		
Existing Head Available? 2-3' Est.

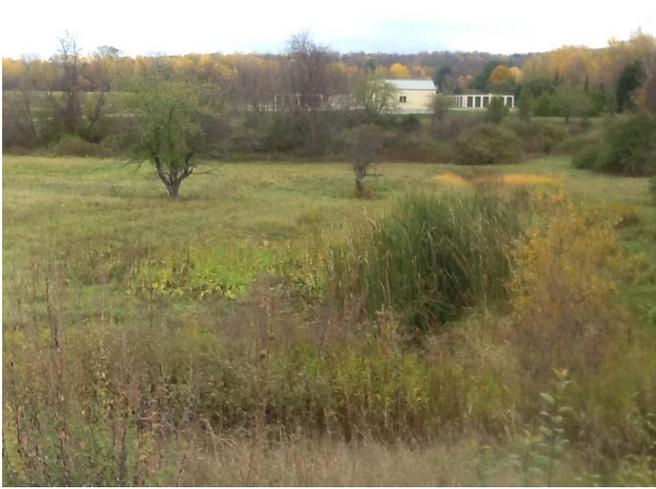
ID#: M29 Option 1		
Name: Shelburne Commons/Rice Lumber

Permit #: N/A		
Concept Description: Construct new wet pond to capture existing impervious from unpermitted site as well as Route 7		
Notes/Feasibility: Good candidate for collecting Rt. 7 runoff, significant head available.		
GENERAL SITE INFORMATION	RETROFIT DETAILS	
Site Contact Info: Shelburne/VTrans	Project Candidate: Tier I	
Ownership:	New or Retrofit BMP: New	
Land Use 1: Commercial	Proposed Retrofit Practice: Pond	
Land Use 2: Transportation	Non-Structural Controls: N/A	
Existing BMP on site? No	Maintenance Burden: Moderate	
Is site a hotspot? No	Benefits: Storage: Yes Water Quality: Yes Recharge: No Repair: No Other: N/A	Conflicts: Soils: No Access: Yes Land Use: Utilities: Yes High WT: Yes Wetlands: Yes Demo: Yes Other: N/A
Soils: D		
SIZING INFORMATION		
Drainage Area (ac): 41.10		
Impervious Area (ac): 16.40		
Practice Area Available(ft²): 10400

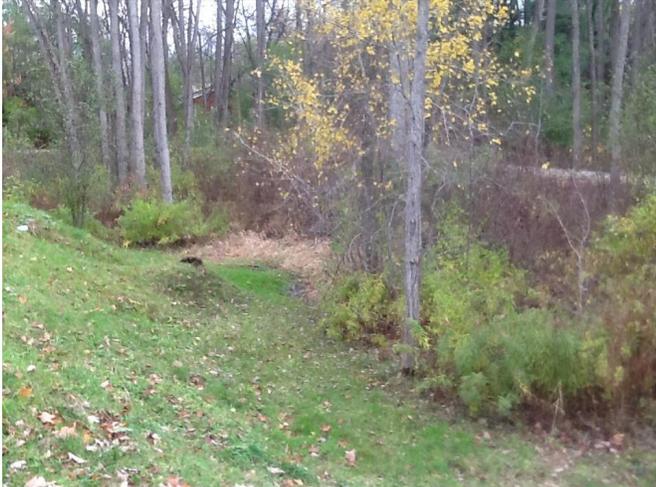
ID#: M32		
Name: Drew Lane

Permit #: N/A		
Concept Description: Retrofit of existing pond to 2002 standards		
Notes/Feasibility: A pond exists in this development that does not appear to have a permit associated with it. Portion of Rt. 7 runoff runs past practice, with relatively easy ability to redirect to the practice.		
GENERAL SITE INFORMATION	RETROFIT DETAILS	
Site Contact Info: Shelburne/VTrans	Project Candidate: Tier I	
Ownership:	New or Retrofit BMP: Retrofit	
Land Use 1: Residential	Proposed Retrofit Practice: Pond	
Land Use 2: Transportation	Non-Structural Controls: N/A	
Existing BMP on site? Yes	Maintenance Burden: Moderate	
Is site a hotspot? No	Benefits: Storage: Yes Water Quality: Yes Recharge: Yes Repair: No Other: N/A	Conflicts: Soils: No Access: Yes Land Use: No Utilities: No High WT: Unknown Wetlands: No Demo: No Other: N/A
Soils: B		
SIZING INFORMATION		
Drainage Area (ac): 19.70

Impervious Area (ac): 4.40		
Practice Area Available(ft ²): 7700		
Existing Head Available? >5'

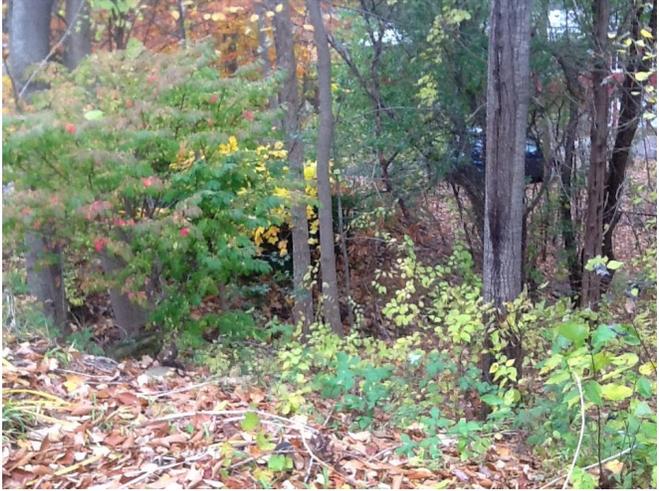
ID#: M34		
Name: Hullcrest South

Permit #: N/A		
Concept Description: Construction of new BMP to capture existing unpermitted impervious		
Notes/Feasibility: Area can not feasibly be drained to an existing nearby practice. Proposed practice located in wooded area along a property line.		
GENERAL SITE INFORMATION	RETROFIT DETAILS	
Site Contact Info: Shelburne	Project Candidate: Tier II	
Ownership:	New or Retrofit BMP: New	
Land Use 1: Residential	Proposed Retrofit Practice: Pond	
Land Use 2:	Non-Structural Controls: N/A	
Existing BMP on site? No	Maintenance Burden: Moderate	
Is site a hotspot? No	Benefits: Storage: Yes Water Quality: Yes Recharge: No Repair: No Other: N/A	Conflicts: Soils: No Access: Yes Land Use: No Utilities: No High WT: Unknown Wetlands: No Demo: No Other: N/A
Soils: D		
SIZING INFORMATION		
Drainage Area (ac): 20.60		
Impervious Area (ac): 4.30		
Practice Area Available(ft²): 3400

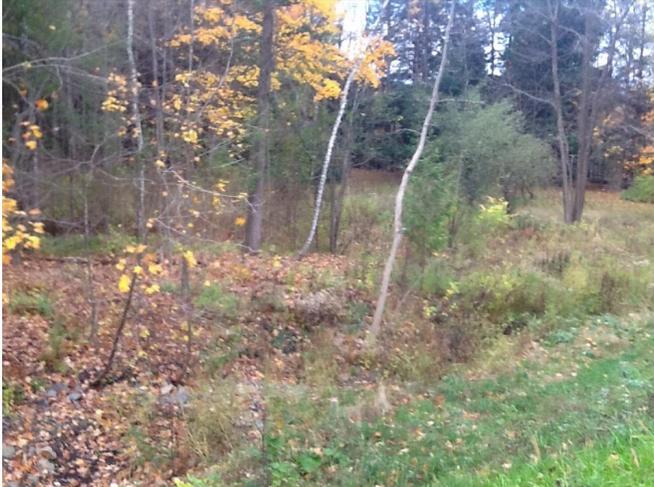
ID#: M35				
Name: Morse Drive Neighborhood

Permit #: N/A				
<p>Concept Description: The existing drainage system for the proposed practice DA daylights to a single discharge adjacent to a recently constructed home. There appears to be ample area for a pond BMP at this location with good vertical relief for discharge from the practice.</p>				
<p>Notes/Feasibility: Strong candidate site due to presence of existing network of ditches, culverts, and drain piping directing the majority of runoff to single point.</p>				
GENERAL SITE INFORMATION		RETROFIT DETAILS		
Site Contact Info: Shelburne		Project Candidate: Tier I		
Ownership:		New or Retrofit BMP: New		
Land Use 1: Residential		Proposed Retrofit Practice: Pond		
Land Use 2:		Non-Structural Controls: No		
Existing BMP on site? No		Maintenance Burden: Moderate		
Is site a hotspot? No		<table border="0" style="width: 100%;"> <tr> <td style="vertical-align: top;"> <p>Benefits: Storage: Yes Water Quality: Yes Recharge: No</p> </td> <td style="vertical-align: top;"> <p>Conflicts: Soils: No Access: No Land Use: Utilities: No High WT: Unknown Wetlands: No Demo: No Other: N/A</p> </td> </tr> </table>	<p>Benefits: Storage: Yes Water Quality: Yes Recharge: No</p>	<p>Conflicts: Soils: No Access: No Land Use: Utilities: No High WT: Unknown Wetlands: No Demo: No Other: N/A</p>
<p>Benefits: Storage: Yes Water Quality: Yes Recharge: No</p>	<p>Conflicts: Soils: No Access: No Land Use: Utilities: No High WT: Unknown Wetlands: No Demo: No Other: N/A</p>			
Soils: C				
SIZING INFORMATION				
Drainage Area (ac): 23.20				
Impervious Area (ac): 3.89				
Practice Area Available(ft²): 4500				
Existing Head Available? >10'				
Other: N/A
